Revolt Systems Rotor Seal Bypass Manifold “The Fix”
(Affects all Tesla Large Drive Units)

This procedure addresses the notorious rotor seal issues present in all Tesla Large Drive Units (LDU). The seal and sealing surface degrade and allows coolant to leak into the stator windings and inverter. This causes isolation issues, inverter failure and in some cases complete motor seizure. If the rotor seal has not yet leaked, this kit will eliminate all risk of rotor seal failure in the future.

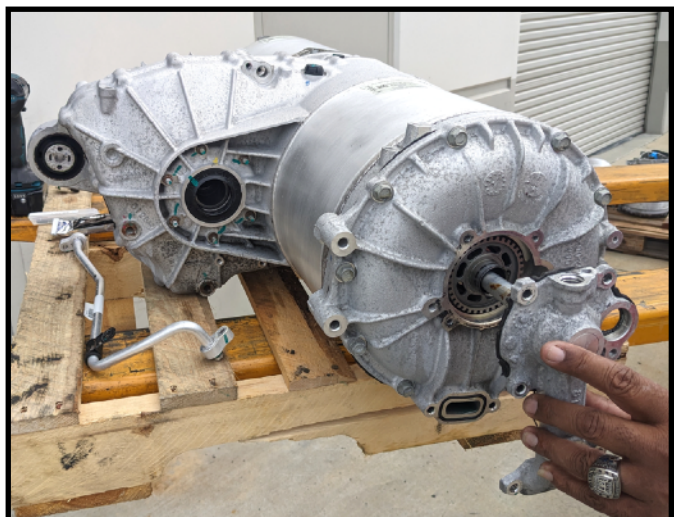
A small amount of coolant will be present when the manifold is removed. This is normal. If you find rust and corrosion on the encoder wheel and rotor bearing, this is an indicator that the rotor seal has already begun leaking. In this case your motor may be salvageable or it may need to be rebuilt. Revolt Systems works with several specialists who are able to rebuild these motors. If you believe your rotor seal has been leaking, contact info@revoltsystems.com with photos and your location, and we may be able to refer you to a rebuilder.
