Revolt Systems Rotor Seal Bypass Manifold “The Fix”
(Affects all Tesla Large Drive Units)

This procedure addresses the notorious rotor seal issues present in all Tesla Large Drive Units (LDU). The seal and sealing surface degrade and allows coolant to leak into the stator windings and inverter. This causes isolation issues, inverter failure and in some cases complete motor seizure. If the rotor seal has not yet leaked, this kit will eliminate all risk of rotor seal failure in the future.

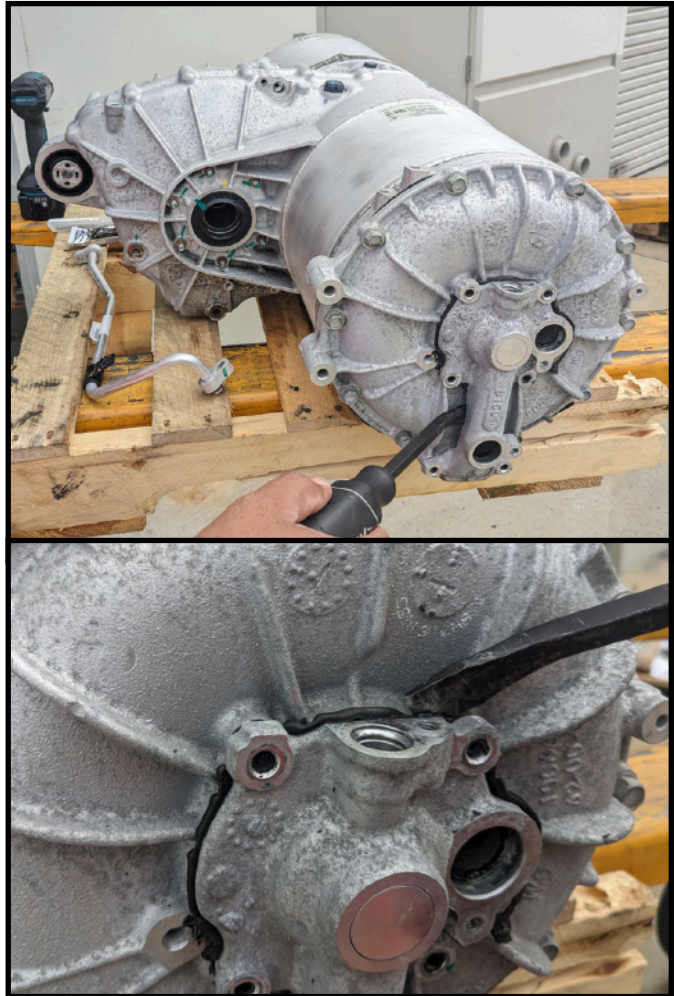
A small amount of coolant will be present when the manifold is removed. This is normal. If you find rust and corrosion on the encoder wheel and rotor bearing, this is an indicator that the rotor seal has already begun leaking. In this case your motor may be salvageable or it may need to be rebuilt. Revolt Systems works with several specialists who are able to rebuild these motors. If you believe your rotor seal has been leaking, contact info@revoltsystems.com with photos and your location, and we may be able to refer you to a rebuilder.

Use a pry-bar to carefully remove the rotor seal manifold. There are two convenient pry points shown in these photos, but take care to pry it off evenly and as square as possible to the drive unit.
